Manhole Inspection Summary

Manhole # S39QQ_016MH

Location Address: **2450 HOMEWOOD AVE**

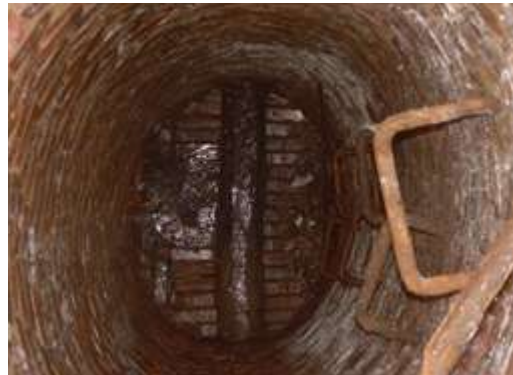
Top View

Corroded steps. Bench debris.

Cracked sidewalk

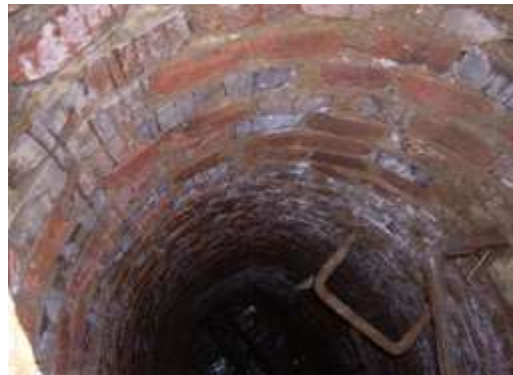
Defect

☒ **Leaks**

Condition: ☐ Sound ☐ Cracked ☐ Root Intrusion ☐ Loose Brick ☒ **Deteriorated**

Frame leaks. Frame offset. Adjustment deterioration and infiltration.

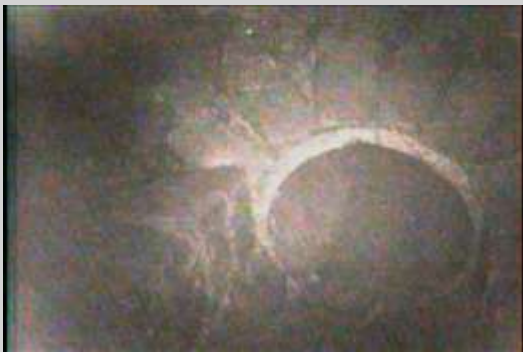
8 in. Circular Gravity Sewer Pipe Out @ 12 O'Clock

Infiltration: **None** Pipe Seal Cond: **Unknown**

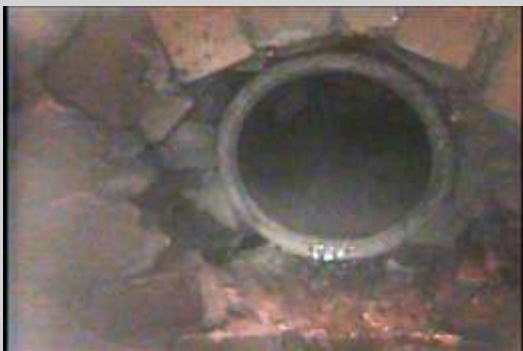
8 in. Circular Gravity Sewer Pipe In @ 6 O'Clock

Infiltration: **None** Pipe Seal Cond: **Unknown**

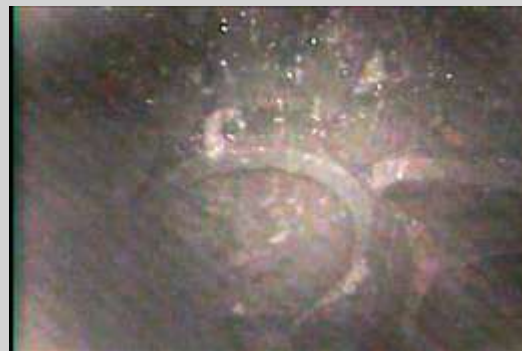
Drop In @ 6 O'Clock

Drop Condition: **Partly Clogged**

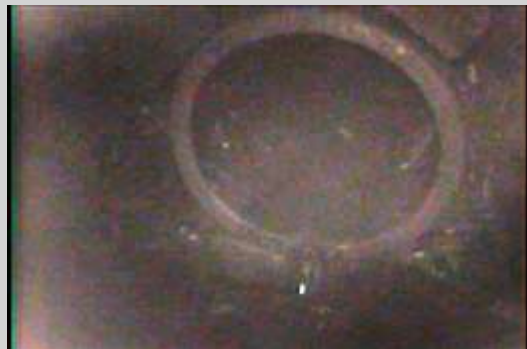
8 in. Circular Gravity Sewer

Infiltration: **Evidence**

Pipe Seal Cond: **Broken**
